ADVISORY CIRCULAR 43-16A

AVIATION MAINTENANCE ALERTS

ALERT
NUMBER
281

DECEMBER
2001

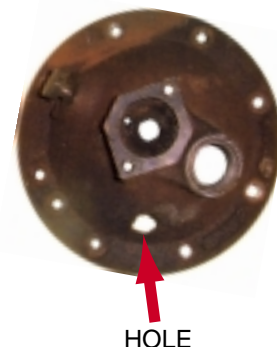
The aircraft owner brought the aircraft to a repair facility with a report that the cabin heater did not work.

The submitter recommended all concerned personnel conduct a visual inspection and/or pressure decay test each 100-hours of heater operation.

Part total time-1,740 hours.

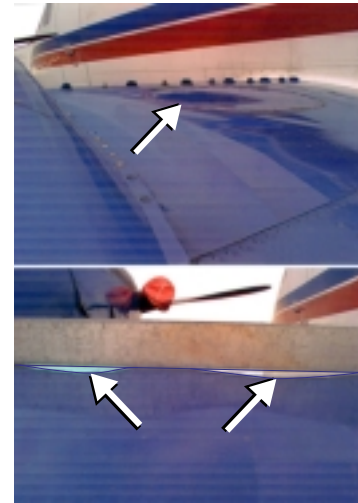
Beech; Model 1900C; Airliner; Left Wing Structural Defect; ATA 5730

During a scheduled inspection, a technician discovered a severe structural defect on the left wing.

The upper wing panel (P/N 114-120036-613) on the left inboard wing was severely buckled and deformed. The damage was located aft of the wing spar where the panel was debonded from the “honeycomb” structure inside the fuel bay. (Refer to the illustration.) The technician speculated this defect is the result of age, many hours of operation, and possibly exceptional and abnormal operational structural stresses.

All operators of like aircraft are cautioned to be vigilant for similar defect.

Part total time-31,242 hours.

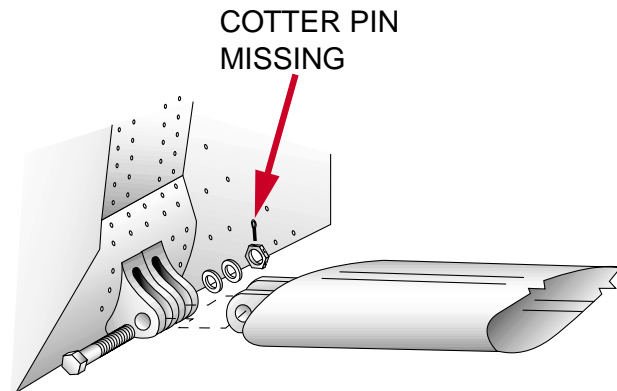
Cessna; Model 208B; Caravan; Defective Wing Strut Attachment; ATA 5741

During the first scheduled inspection of a new aircraft, the technician found the wing lift strut attachment defective.

The bolt cotter pin (P/N MS24665-357) for the left lower lift strut attachment to the fuselage was missing. (Refer to the illustration.) There was no evidence that the cotter pin had ever been installed; therefore, the submitter presumed it was omitted when the aircraft was manufactured. There was evidence that the bolt and nut had rotated, which could allow separation of the nut and loss of the bolt. It is very likely that loss of this attachment would lead to structural failure and wing separation.

The manufacturer's maintenance manual specifies the installation instructions and requires the nut be tightened "snug" and then rotated to the right (tighten) to align the cotter pin holes.

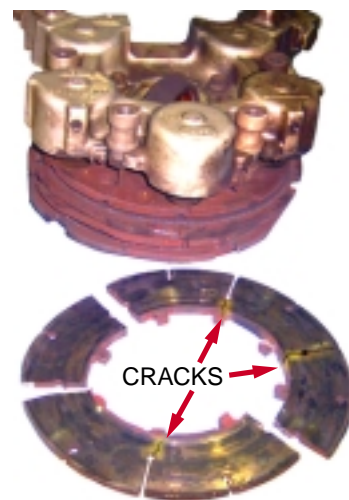
Cessna; Model 550; Citation; Wheel Brake Failure; ATA 3242

Maintenance technicians removed the right main wheel and brake assembly and found that the brake stator (P/N 133-893-2) was broken into three pieces. The pieces of the stator were jammed between the wheel and brake assembly preventing rotation of the wheel. It appeared the brake stator failure originated as cracks at the cooling holes. (Refer to the illustration.) Had the stator failed during a landing, it may have resulted in loss of aircraft control and a catastrophic accident.

The brake assembly (P/N 1528-6) was manufactured by B.F. Goodrich and Cessna has issued Service Bulletin (SB) 550-32-41, which had been complied with on this aircraft and was so marked. The submitter stated, "This seems to be an ongoing problem with these brake stators." The FAA Service Difficulty data base contains five additional reports of similar brake failures and, at this time, the FAA is considering the issuance of an Airworthiness Directive to correct this problem.

Part time since overhaul-838 hours.

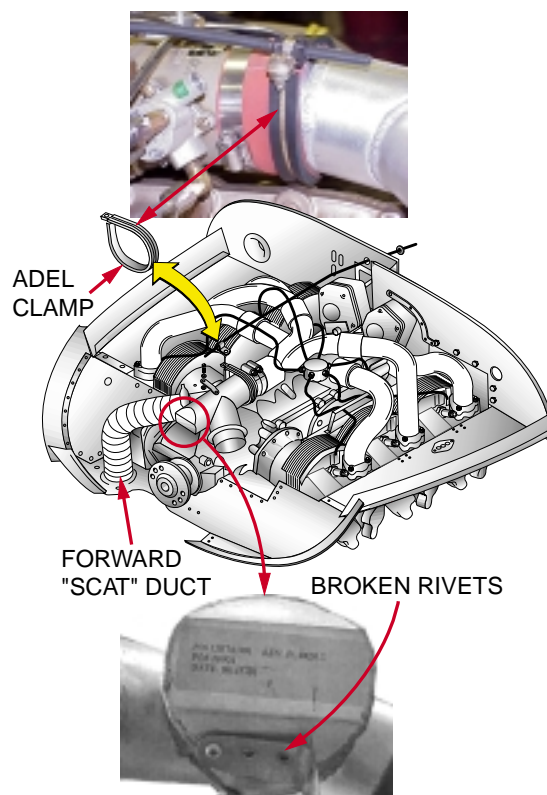
Cirrus; Model SR-22; Improper Engine Induction System Installation; ATA 7160

The “Adel” clamp does not provide the same clamping pressure or forces provided by a worm-drive hose clamp, and the “Adel” clamp is not intended for this use. The improper application of the “Adel” clamp caused the alternate air induction air filter housing end to rotate within the hose joint, the air filter end to contact the engine case, and an attached section of the duct (SCAT hose) to wear against adjacent engine baffling.

The manufacturer’s technical data (maintenance manual) depicts the use of two worm-drive hose clamps used to secure the hose joint and an “Adel” clamp for attachment of the alternate air valve cable. (Refer to the illustrations.)

In addition, a small stainless steel “L-shaped” bracket supports the forward end of the airbox air filter and air valve assembly. The bracket is attached to the engine case with a bolt and to the airbox (P/N 13874-00) by three “blind” rivets. Movement of the airbox, via the Adel clamp, caused two of the three blind rivets to fail.

The submitter recommended that owners of like aircraft conduct a one-time inspection to ensure the engine induction air system is properly installed. An important lesson can be learned from this discrepancy. Never assume the installation of a component is correct even if, “it came that way from the factory.”

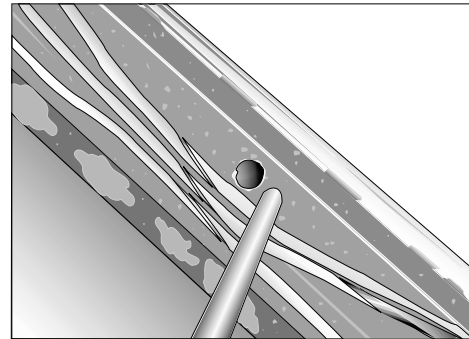
Piper; Model J3; Cub; Engine Failure; ATA 7414

The aircraft was destroyed in an accident when the engine failed during takeoff. The FAA investigated the accident.

During the accident investigation, the FAA inspector determined the most probable cause of the engine failure occurred when both magneto “P-lead” wires were grounded. The “P-lead” wires were grounded to a screw that secures the left inner and outer window trim strips. After removing the magneto switch wiring, the inspector found that both “P-lead” wires had chafed against the screw threads until the insulation was penetrated. Grounding of the “P-lead” wires had the same effect as turning off both magneto switches. (Refer to the illustration.)

It appeared the inner window trim piece had been altered from the original design. The original fasteners attaching the trim were drilled out to accommodate the installation of longer screws and nuts.

The submitter suggested that all operators of like aircraft conduct a one-time inspection to determine if the window trim pieces have been modified by installation of the longer screws and nuts. Any such installation should be immediately removed, so the aircraft can be returned to the original configuration. In addition, inspect the magneto wiring in this area and correct any damage found.

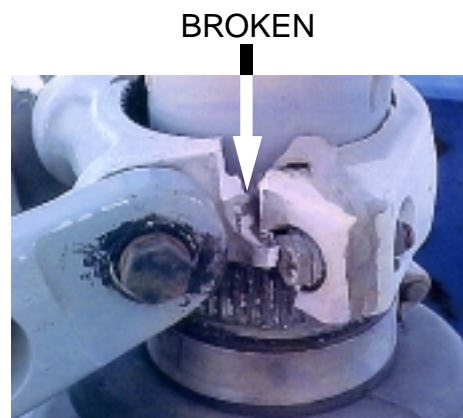
Bell; Model 206L-4; Long Ranger; Main Rotor Collar Failure; ATA 6230

The submitter offered no cause for this defect.

Part total time-573 hours.
